Remediation of BTEX and CHCs at Volvo Car Gent

CASE STUDY

In situ groundwater treatment without disruption
at an active car manufacturer in Belgium

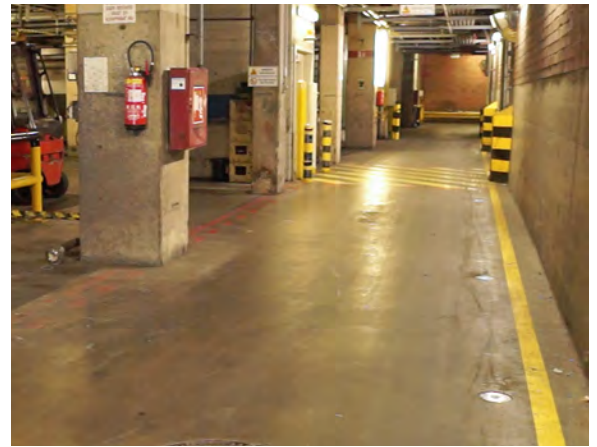
Fig. 3 Pilot test location in Treatment Area 1

REGENESIS first completed a pilot test in Area 1, located inside the factory buildings. This 15m long permeable reactive barrier was created to confirm field conditions and inform the full-scale remedial design. Monitoring was completed for 6 months following injection both inside and downgradient of the barrier. The graph below shows the total BTEX concentrations were reduced by 99% within 6 months post application.

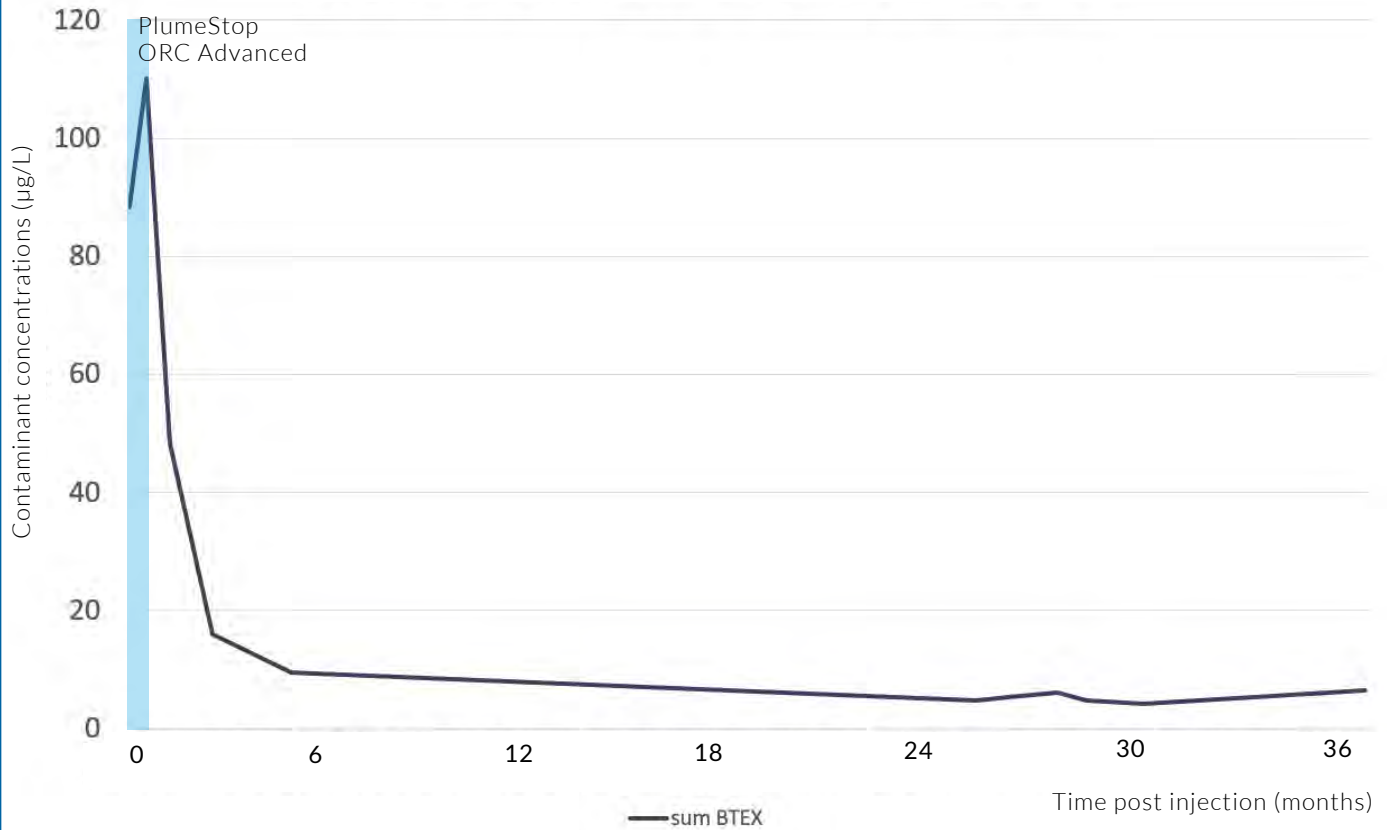
Fig. 5 BTEX concentrations: Pilot area downgradient wells

Monitoring wells downgradient of pilot area show a rapid and significant reduction in contaminant concentrations in the months following injection. The concentrations have then been maintained or reduced further over almost 3 years of validation monitoring.

Following the successful pilot, the full-scale barrier installation was designed and injected onsite two years later. There was no need to re-apply within the pilot area, due to biological degradation on the colloidal activated carbon, regenerating the sorption sites on the PlumeStop, so that the barrier constantly removes and degrades contaminant influx.

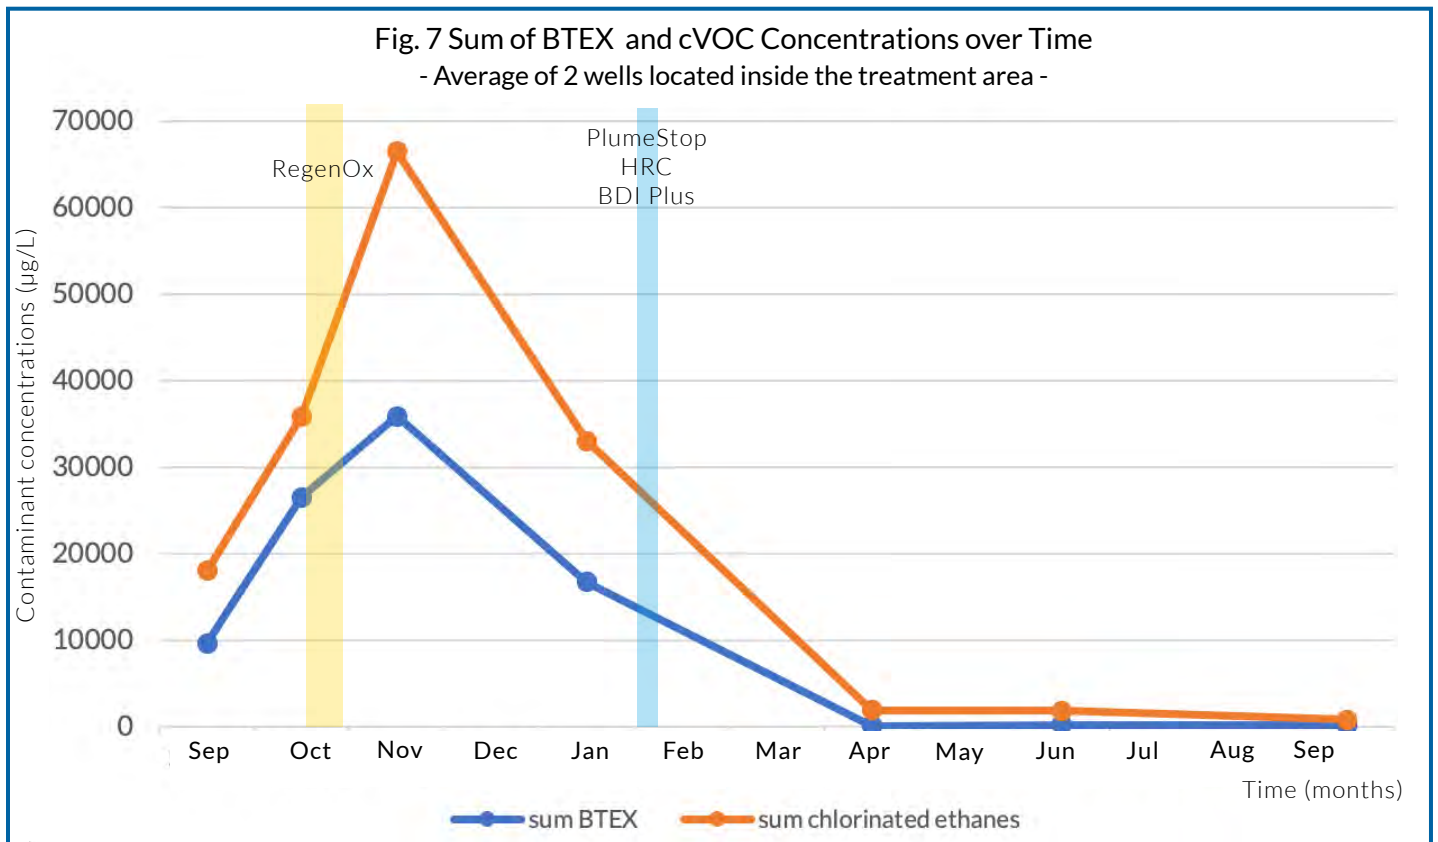
The RegenOx applications resulted in rapidly destroying a large amount of contaminant mass, allowing the PlumeStop application to efficiently target the residual contamination. Challenging concentrations for the PlumeStop treatment remained elevated for both BTEX and cVOC. However the technology demonstrated the ability to reduce the concentration from up to several tens of mg/L, to <1 mg/L, with an ongoing decreasing trend.
